# Manhole Inspection Summary

Manhole # S29U\_\_009MH

Insp Date: **10/29/08 3:48 PM**

**Location** Address: **1645 Warner St.**

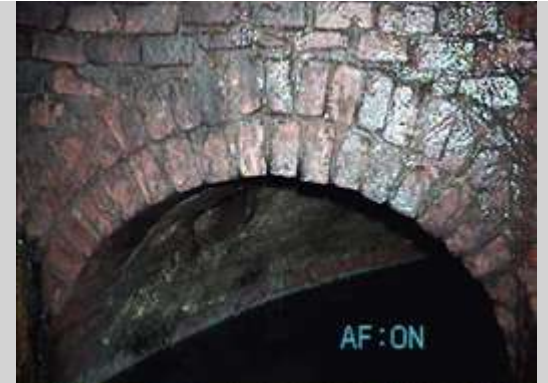
12 O'Clock Outflow

39 in. Circular Gravity Sewer  
Pipe Out @ 12 O'Clock

Pipe Height: **37.2** (in.) Rod and Bar (Angled)  
Pipe Material: **Clay** ☐ Pipe Lined  
Invert Depth: **12.42** (ft.) Flow Characteristics: **Fast**  
Deposits: ☒ None ☐ Mud ☐ Sludge ☐ Debris ☐ Grease  
Silt Depth: **0** (in.) Deposits Extent:  
Infiltration: **None** Pipe Seal Cond: **Sound**

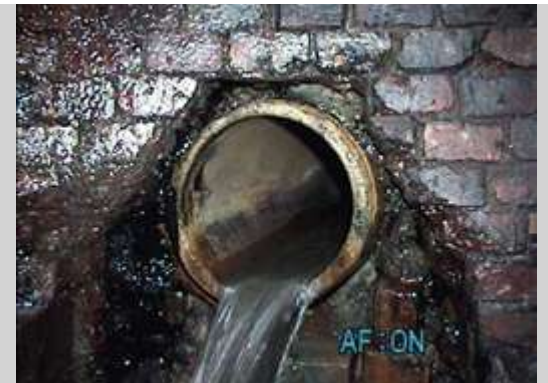
2 O'Clock Inflow

10 in. Circular Gravity Sewer  
Pipe In @ 2 O'Clock

Pipe Height: **10.8** (in.) Rod and Bar (Angled)  
Pipe Material: **Clay** ☐ Pipe Lined  
Invert Depth: **9.82** (ft.) Flow Characteristics: **None**  
Deposits: ☒ None ☐ Mud ☐ Sludge ☐ Debris ☐ Grease  
Silt Depth: **0** (in.) Deposits Extent:  
Infiltration: **None** Pipe Seal Cond: **Sound**
